28th July 2017

Our Ref: TOHA/17/3318/HS Your Ref: O/N 60021878

# Japanese Knotweed and Horsetail Survey: Wissington Sugar Factory

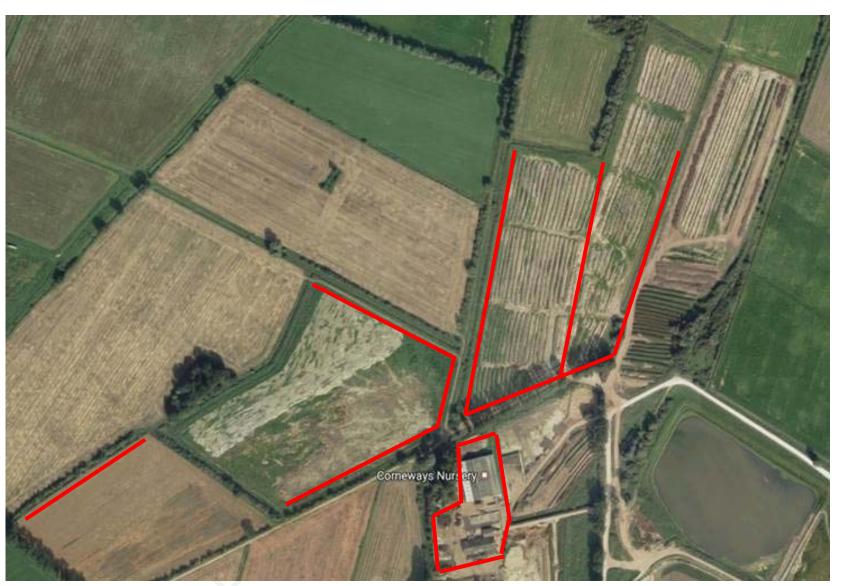
Client:	TOHA/17/3318/HS  3318/JKH/Cornerways			
Project:				
Job ref no.:				
Drawing no.:				
Drawing title				
Date:	July '17	Scale:	NTS	
Drawn by:	HS	Checked by:	LHJ

- ApproximateArea Inspected

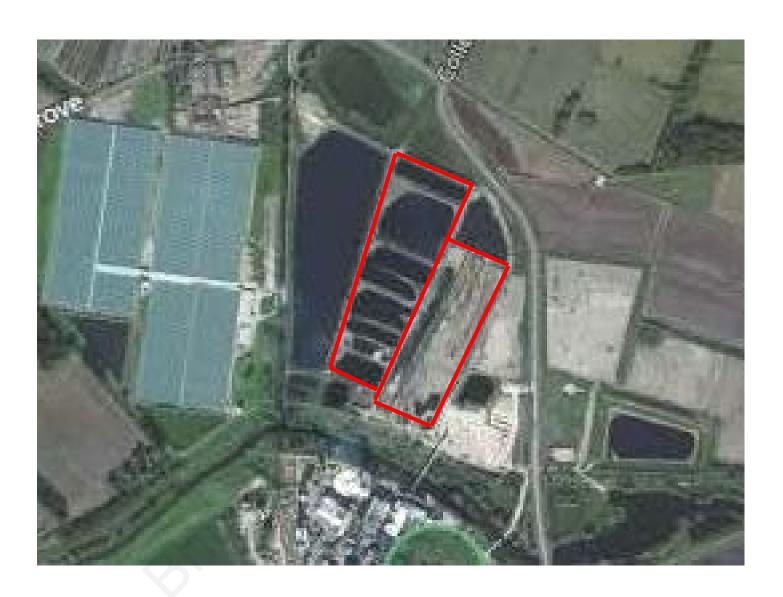
Client:	British Sugar plc			
Project:	Japanese Knotweed and Horsetail Survey  TOHA/17/3318/HS  3318/JKH/Ponds  Wissington Survey			
Job ref no.:				
Drawing no.:				
Drawing title				
Date:	July '17	Scale:	NTS	
Drawn by:	HS	Checked by:	LHJ

- ApproximateArea Inspected
